COASTAL COMMAND REVIEW

February, 1943

No. 10

HEADQUARTERS,
COASTAL COMMAND
ROYAL AIR FORCE

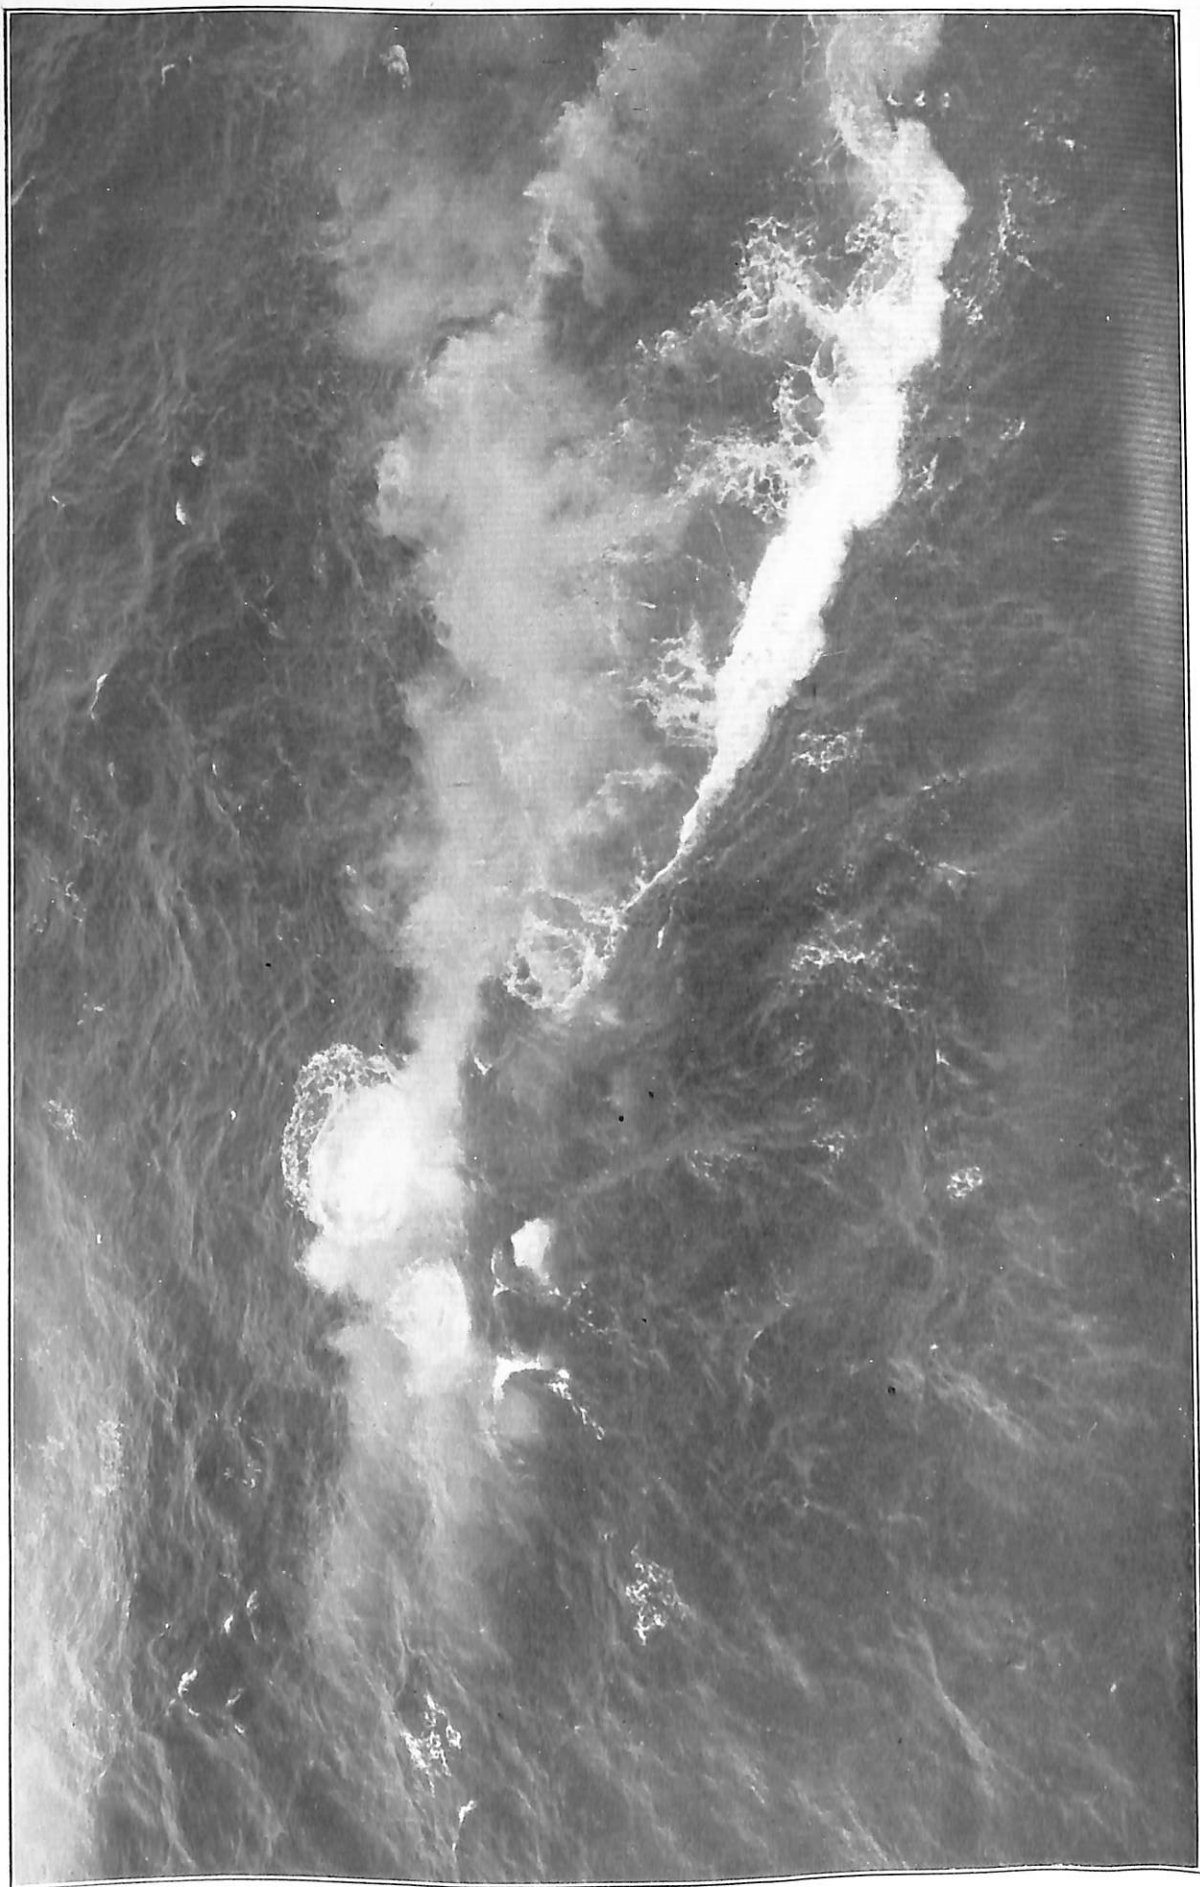
SWIRL OF DIVING U-BOAT. No. 2 U.S.A. A/S SQUADRON. See letterpress, page 10.

The second is when, through damage or other reason, a U-Boat submerges with little or no forward way on the boat. There will be none of the usual white water. Only a small disturbed patch will remain where at the last moment the sea lopped in and filled up the bridge casing, with some bubbles rising in or near it. This is shown in the photograph reproduced as a frontispiece. (T/2 U.S.A.)

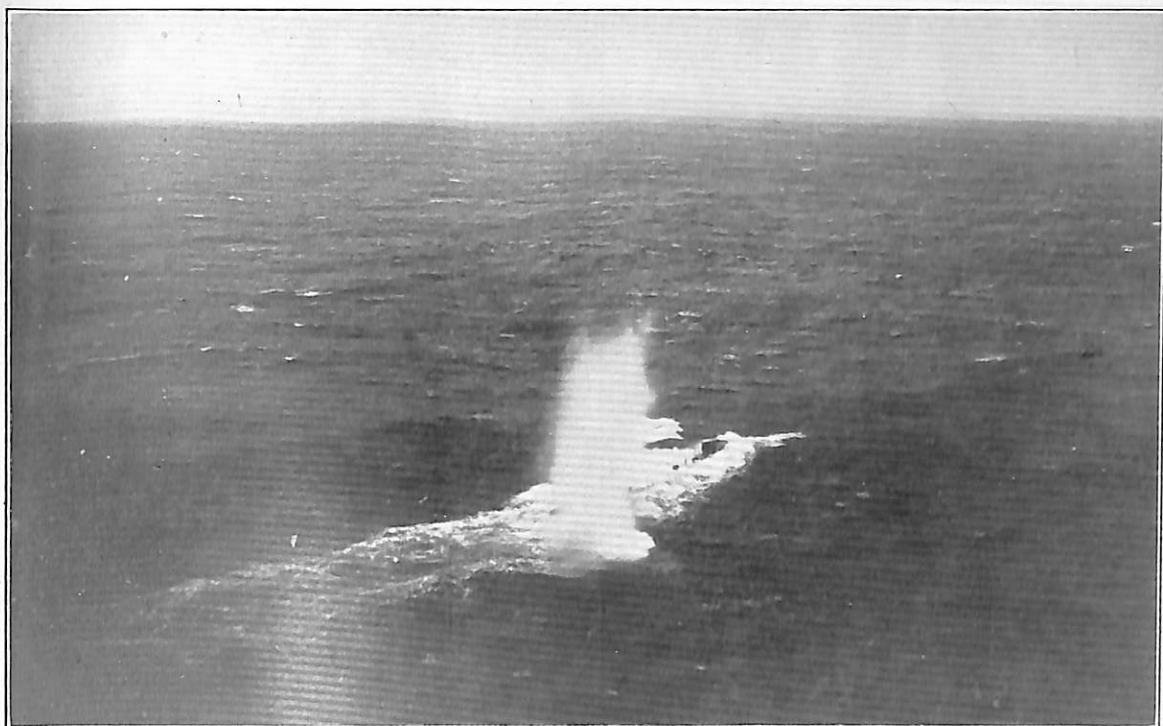
S.120 brings back the ideal photograph after an attack, showing the points of entry of depth-charges relative to the U-Boat.

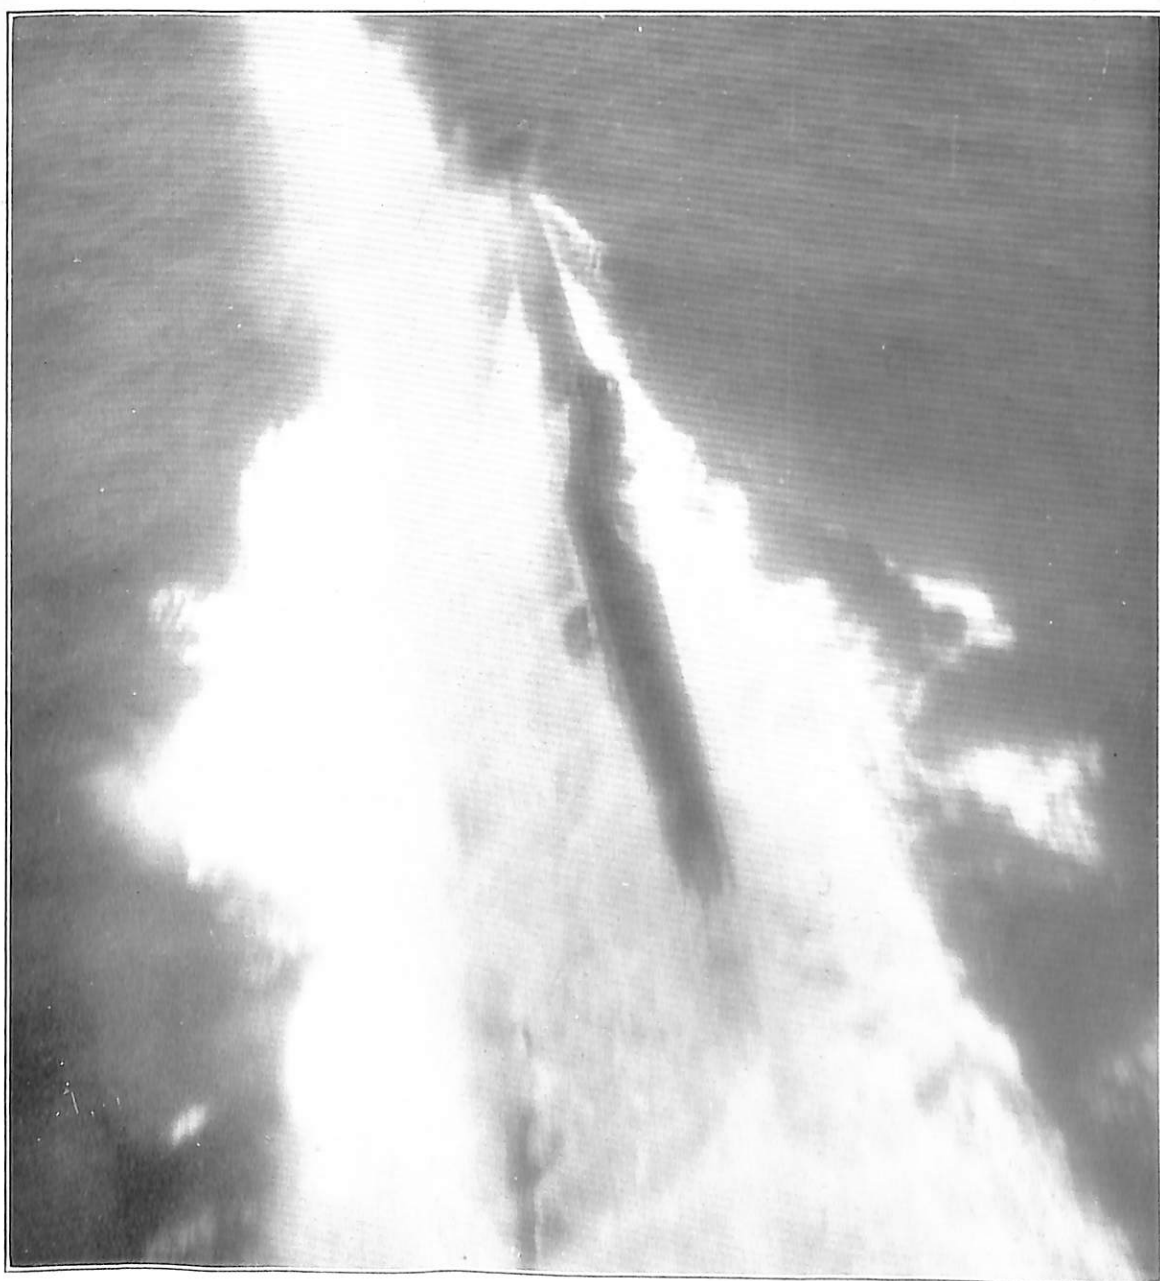
T.120. This photograph shows the first depth charges of the stick entering the water alongside the U-Boat. The attack was made down track.

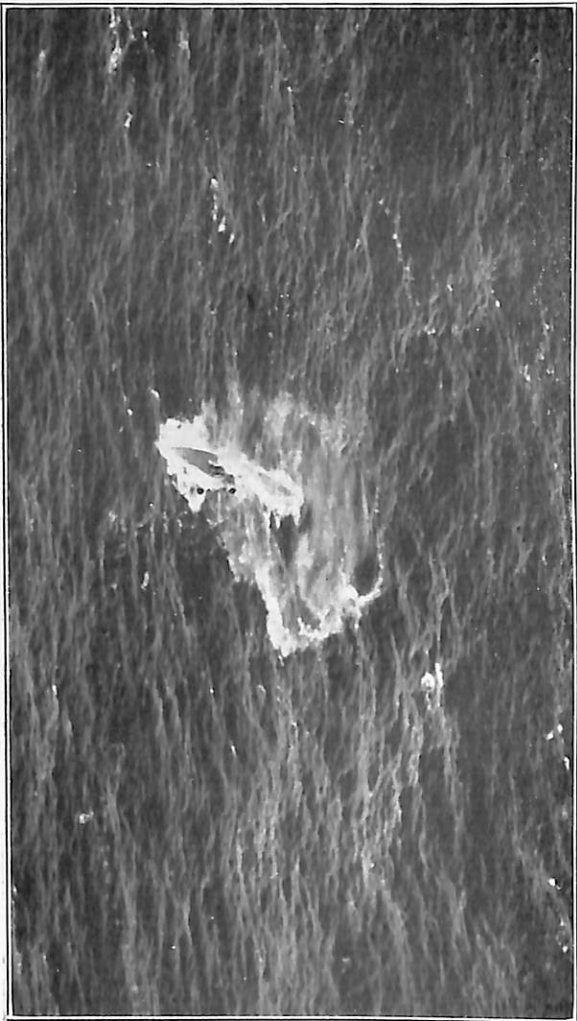
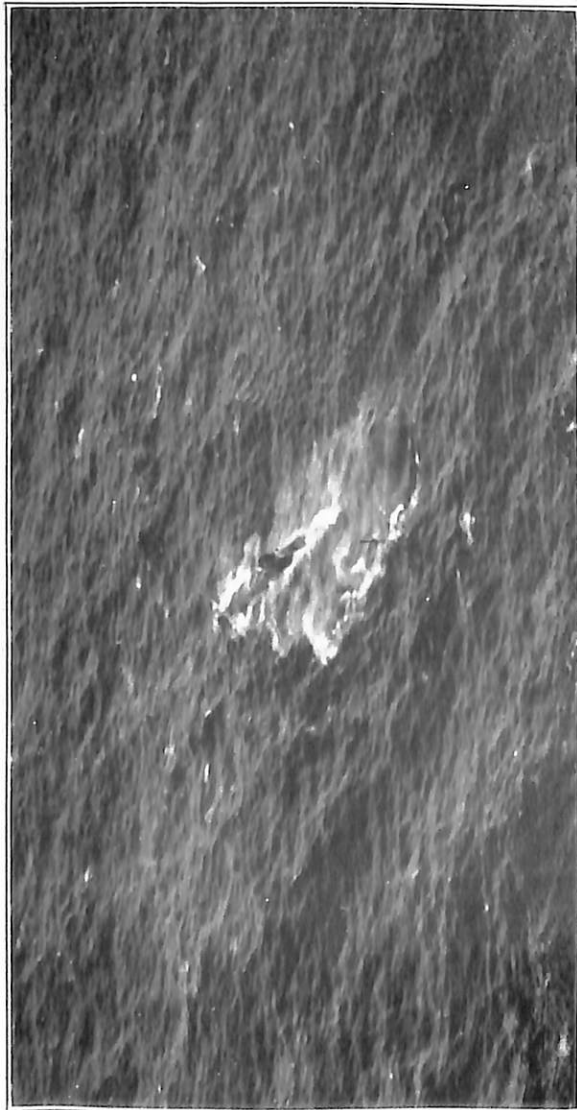
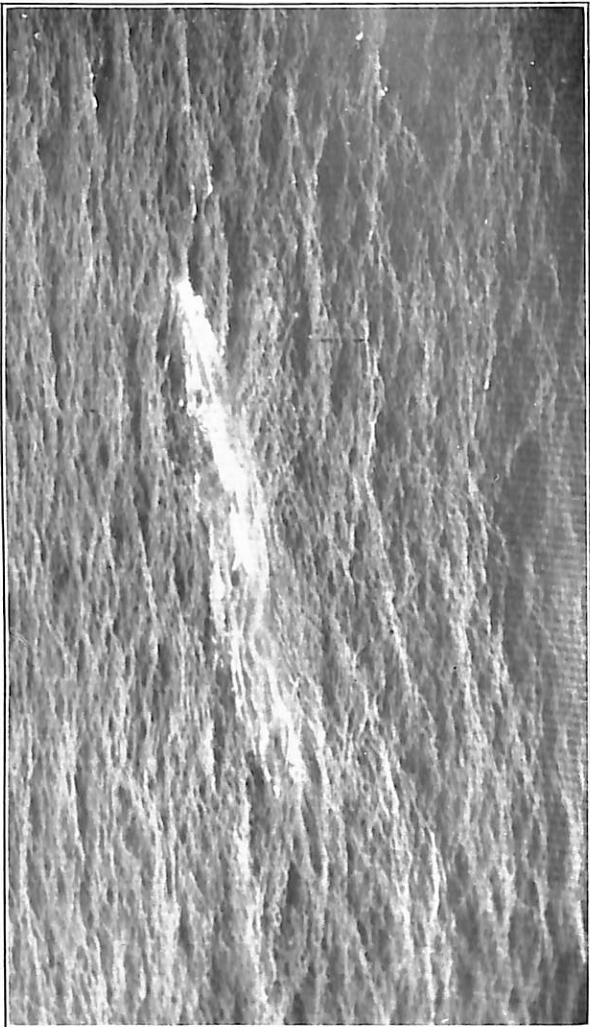
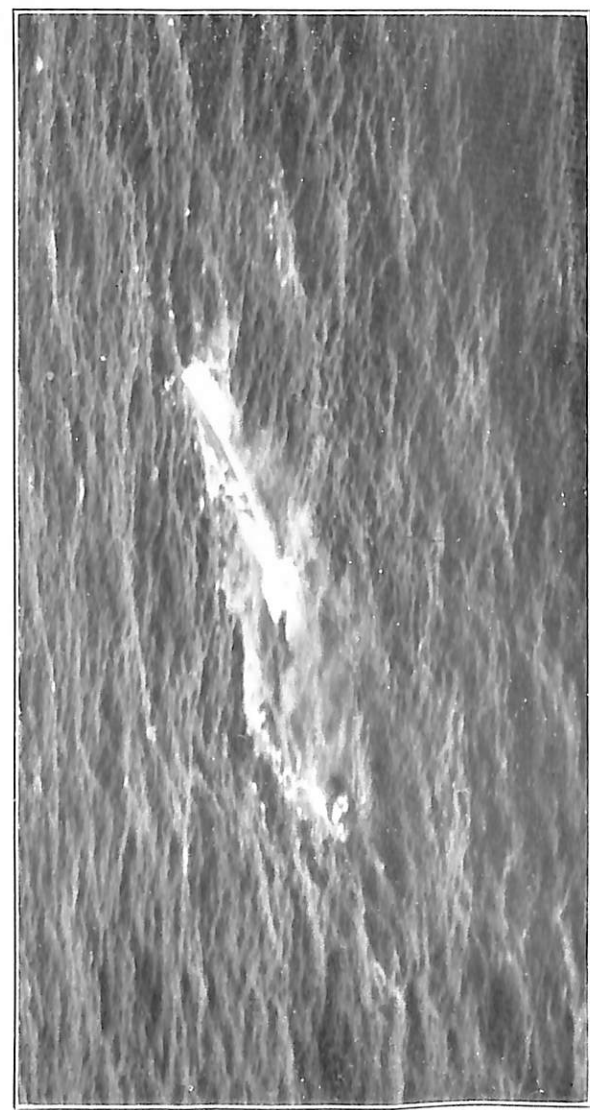
Photograph of U-Boat brought to the surface in a crippled condition after a very good attack by Z/224.

A good approach and an excellent attack. The U-Boat was obviously damaged and the two attempts to dive and the two subsequent re-appearances on the surface indicate that, as well as secondary damage inside the U-Boat, the pressure hull itself was probably split. It is impossible to say what happened to the U-Boat after the aircraft was forced to leave.

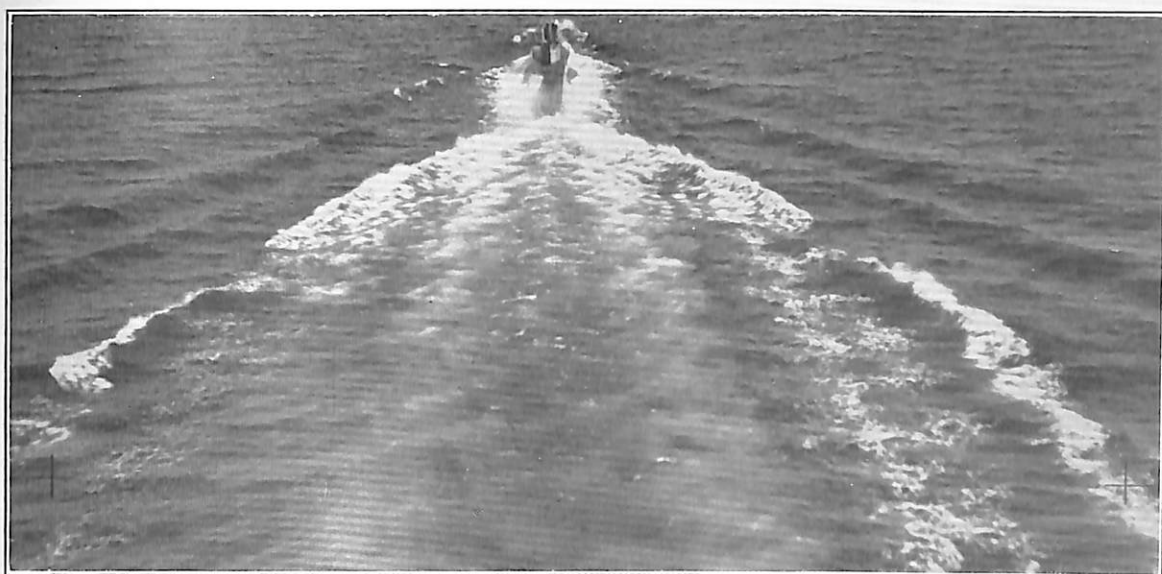
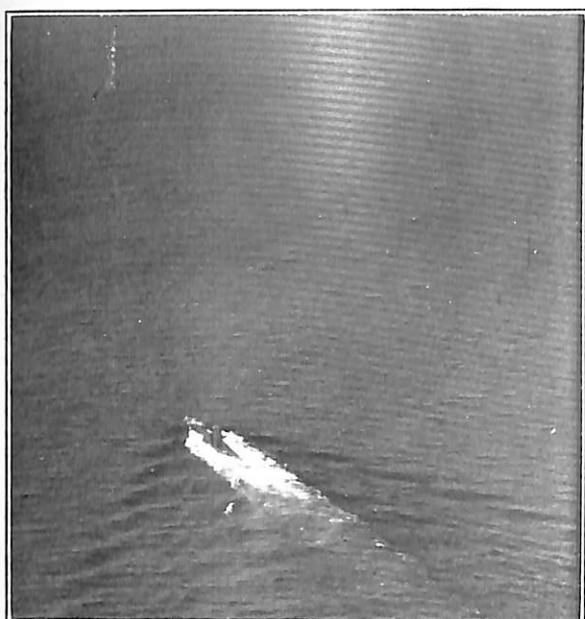
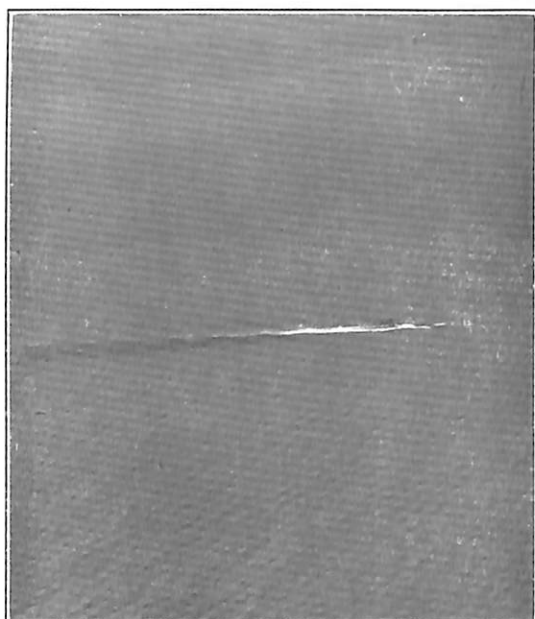
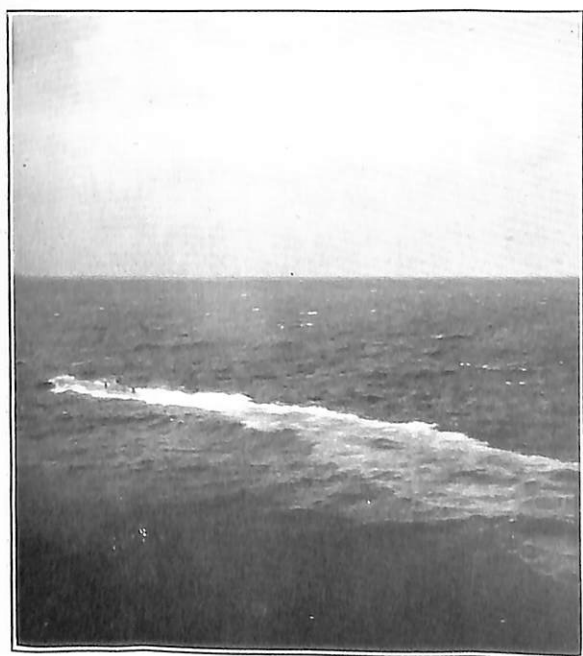
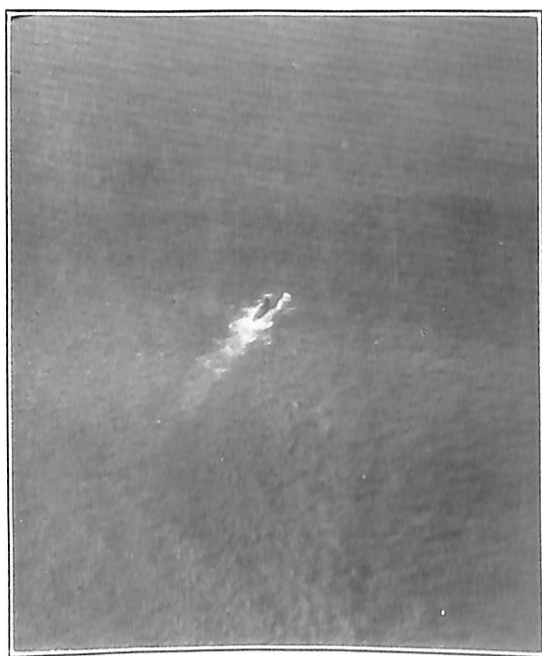
WAKES OF VARIOUS U-BOATS FROM DIFFERENT ANGLES
See letterpress, page 10 (opposite)

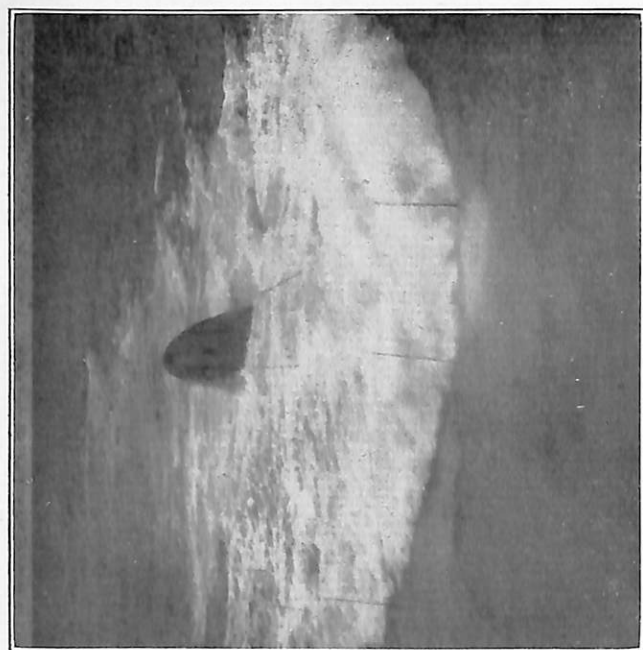
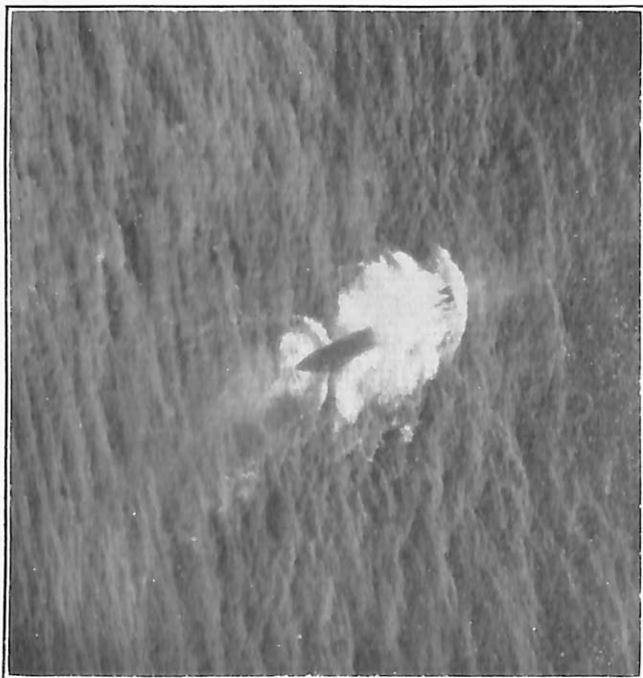
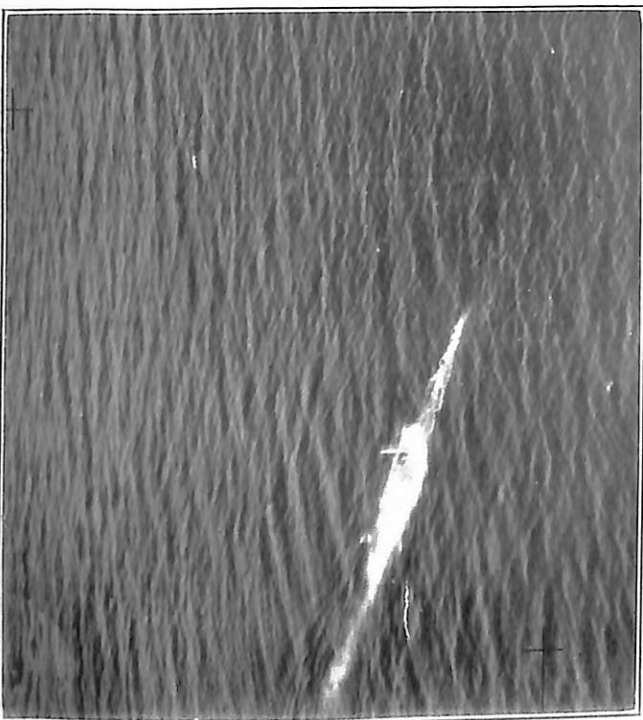
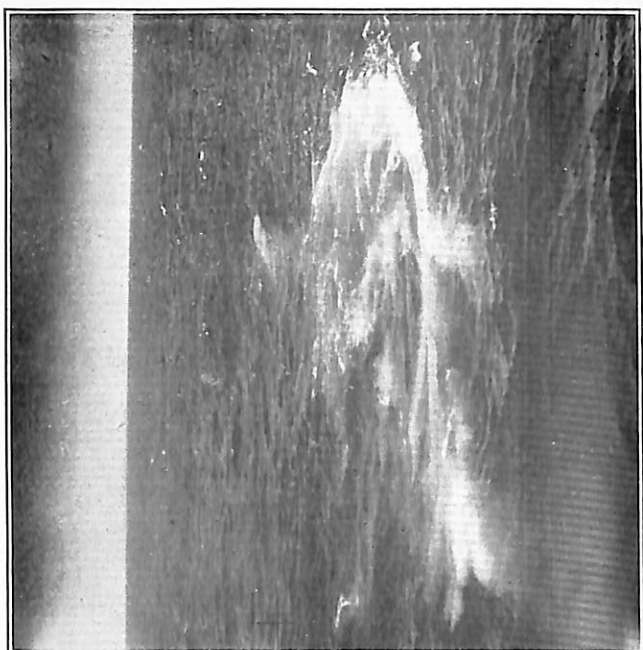
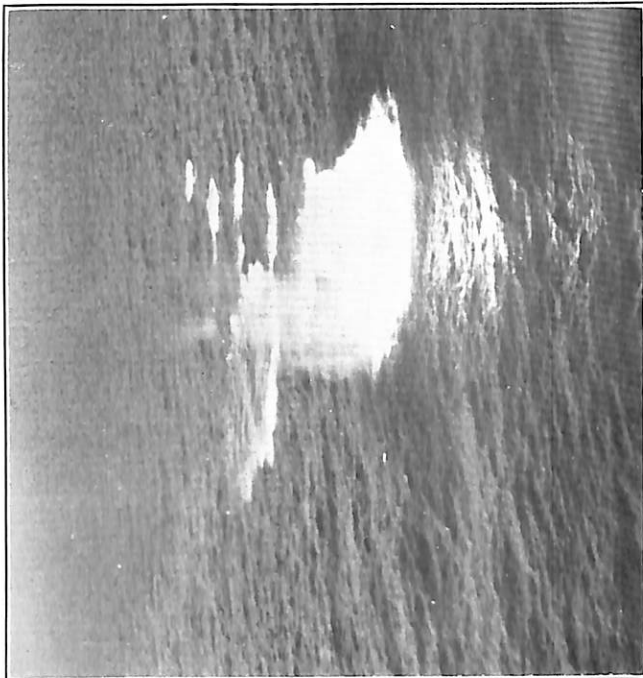
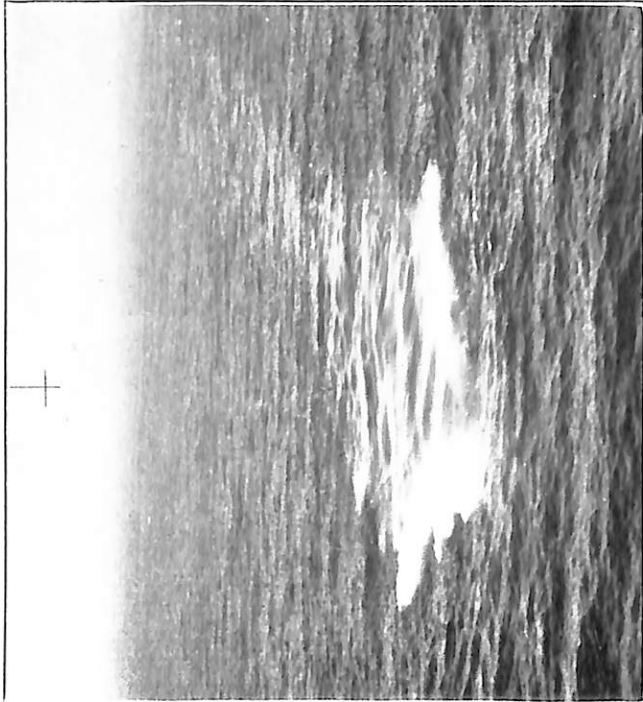
SWIRLS OF VARIOUS U-BOATS FROM DIFFERENT ANGLES. See letterpress, page 10

the shape and size of a swirl is fairly constant, whether in calm or rough weather. It will, of course, fade out or get broken up quickly in a rough sea, but for 30 seconds it will always provide a good yardstick of distance. The white creamy swirlmark is about 100 ft. long and 80 ft. broad. If it is used in reporting the distance ahead at which the centre of a stick fell it should be clearly stated as to whether it is so many swirl's lengths or so many swirl's breadths ahead of the apex of the swirl. The *apex* of the swirl is the last marked position of the conning tower and it is from this point that, knowing the interval since disappearance, the position of the invisible conning tower can be calculated, at release of the depth-charges.

There are two occasions when the swirl mark will not be a regular shape. The first is when the U-Boat dives under helm. In this case the mark will be lopsided, with most of the white water to the side opposite to which the U-Boat is turning. Photo 11 shows this clearly. The wake can be seen in the background and the U-Boat has dived under starboard wheel or turning to its right.

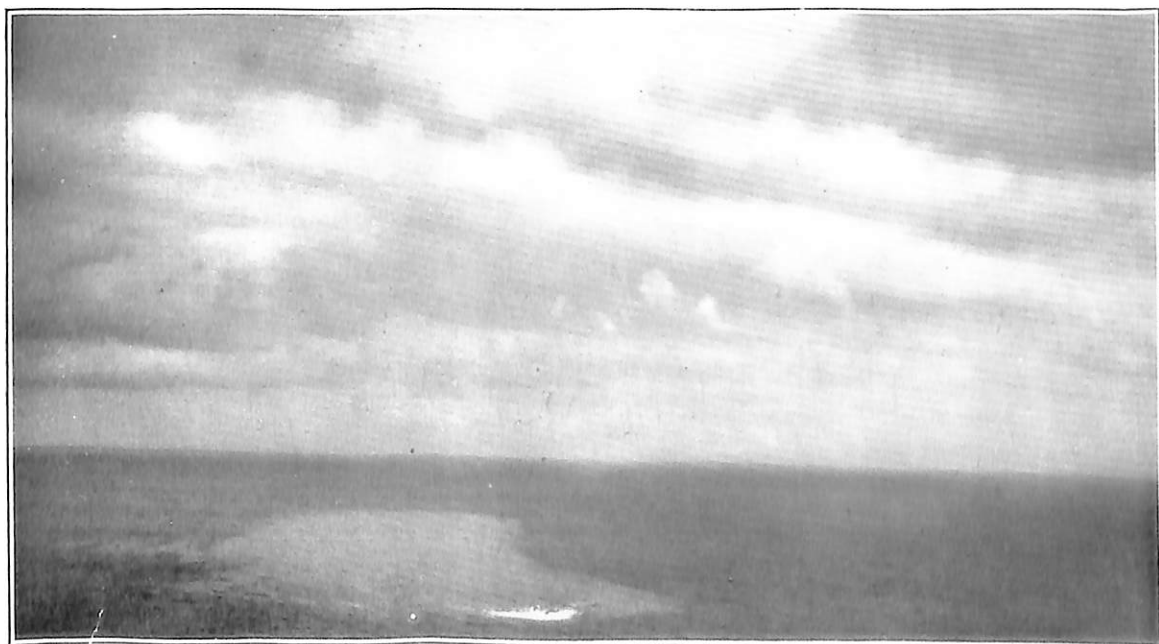
As referred to in the Shipping Notes on p. 11 and again on p. 13, Fortress C-59 was present at the destruction of a blockade-running tanker. The top photograph shows the burning tanker. In the middle one some of the survivors may be seen leaving the doomed ship. The lower photograph shows the last stage.

While searching for the tanker, Fortress C/59 sighted and engaged a F.W.200 at 1655. Having broken off the combat and resumed patrol, the Fortress sighted the tanker at 1745, well afire and sinking. Four lifeboats were seen with about 50–80 survivors, 2 miles north of the burning tanker. The Fortress took photographs and signalled "Tanker sunk" at 1810.

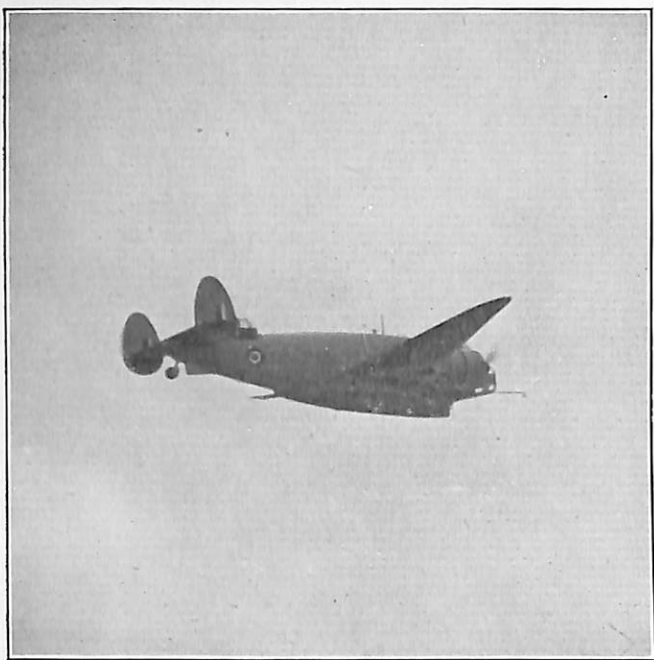
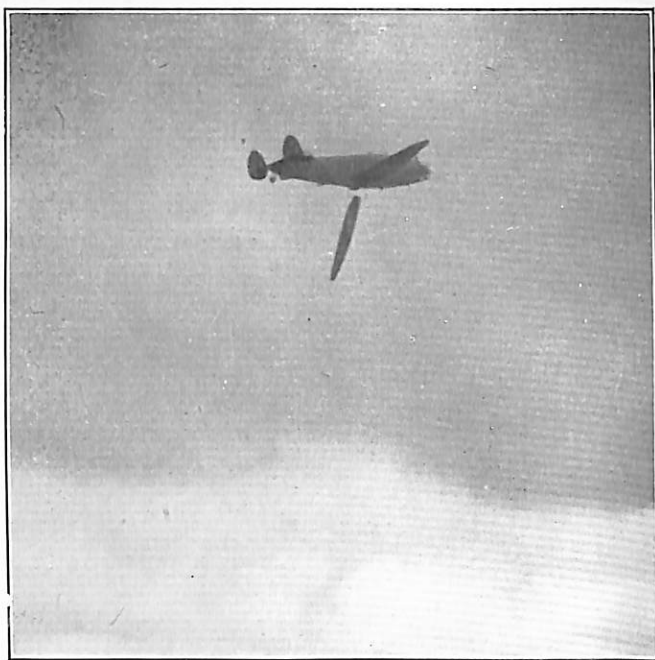
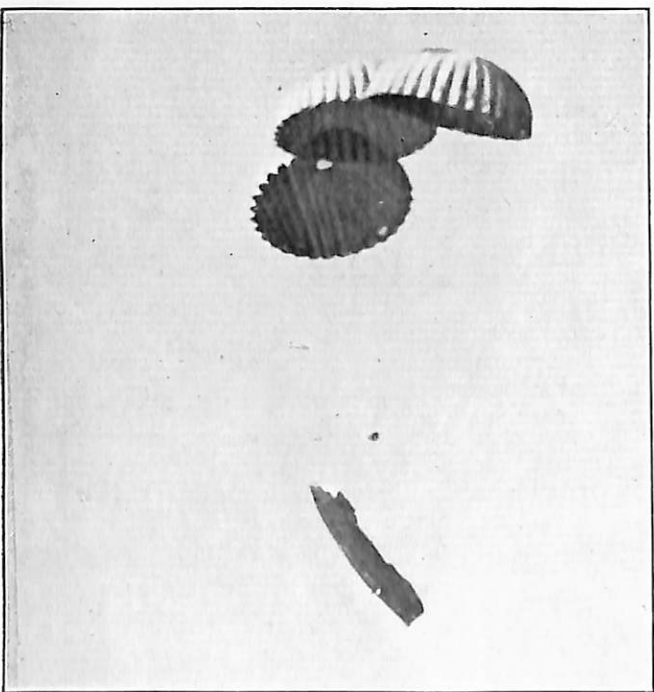
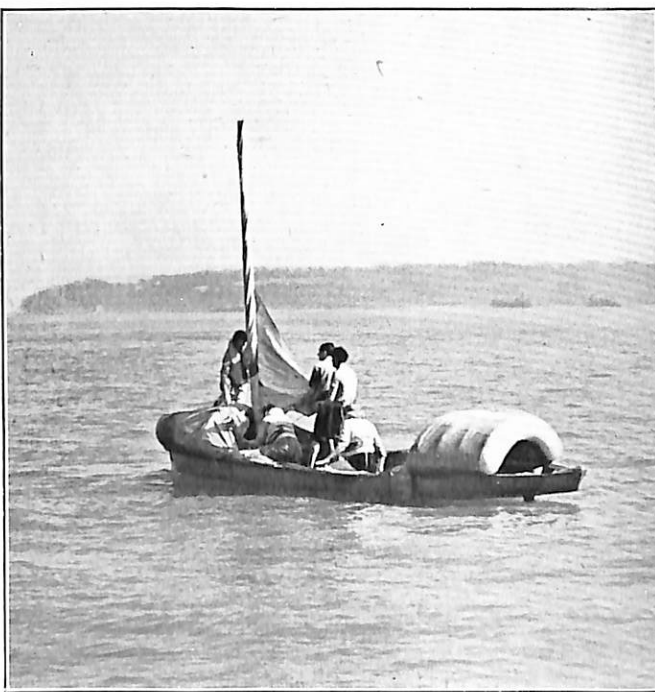
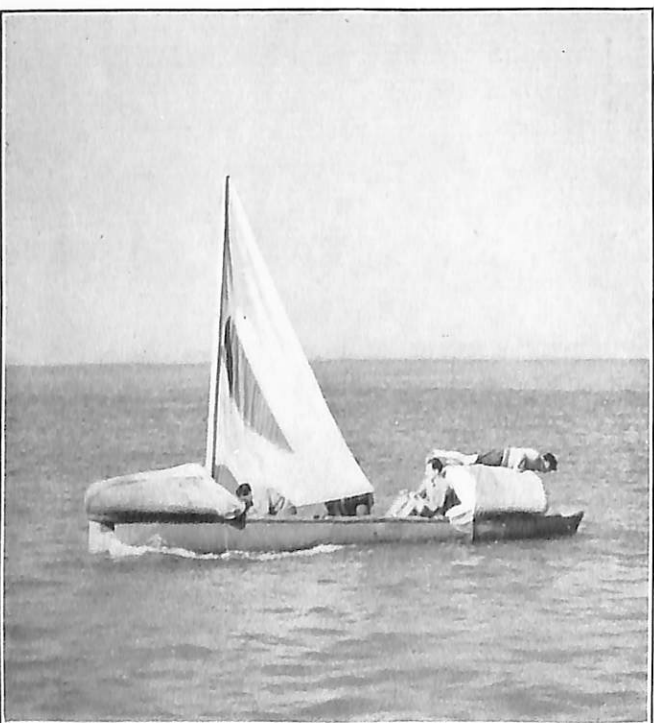
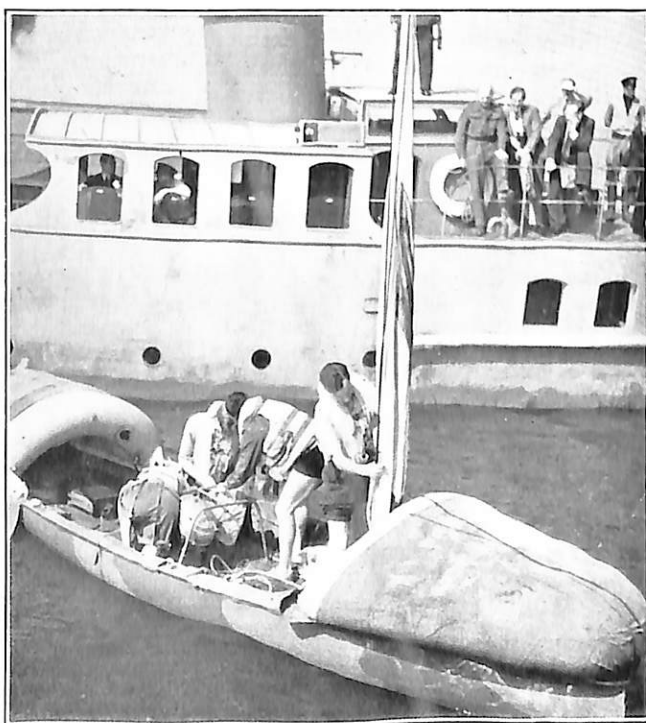
Photographs 1, 2 and 3 show an air-borne life-boat being released from a Hudson aircraft. Photographs 4, 5 and 6 show the life-boat with sails set and in operation.

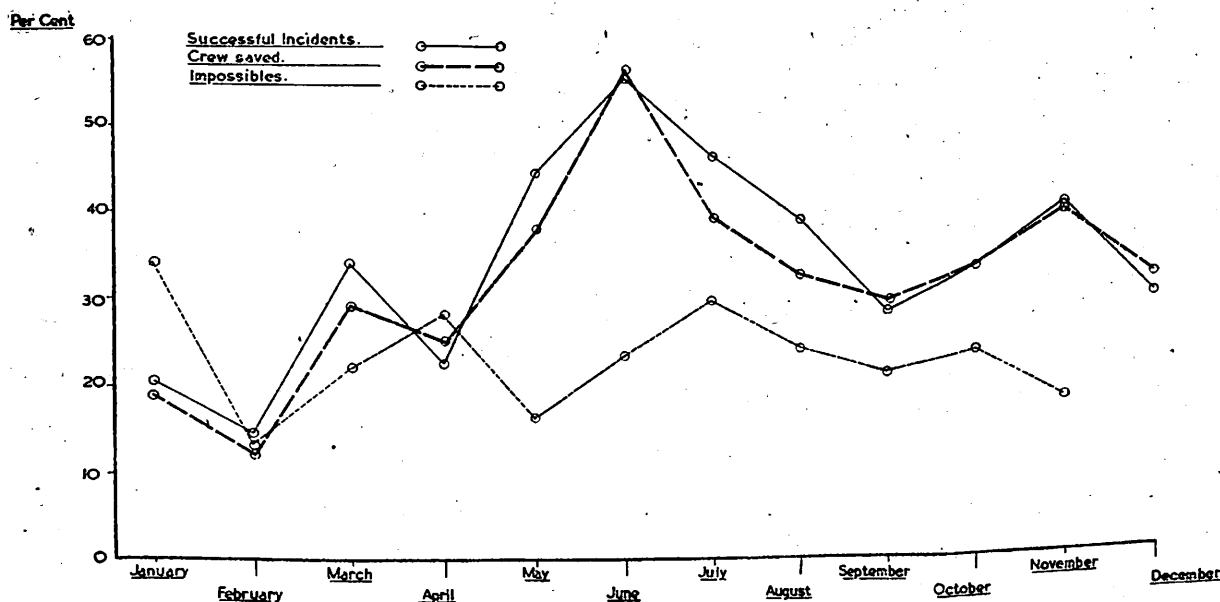
Chart showing percentage of Air Sea Rescues carried out during 1942.

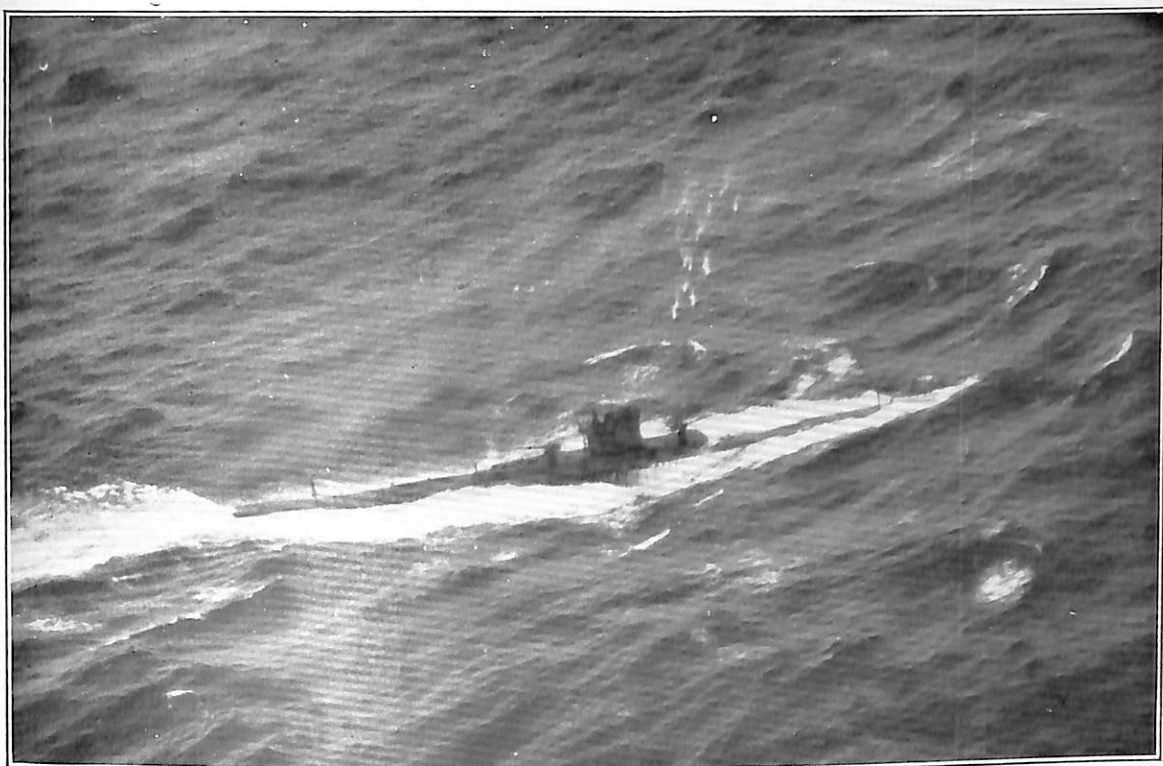
A large U-Boat, sighted and attacked by I/461.

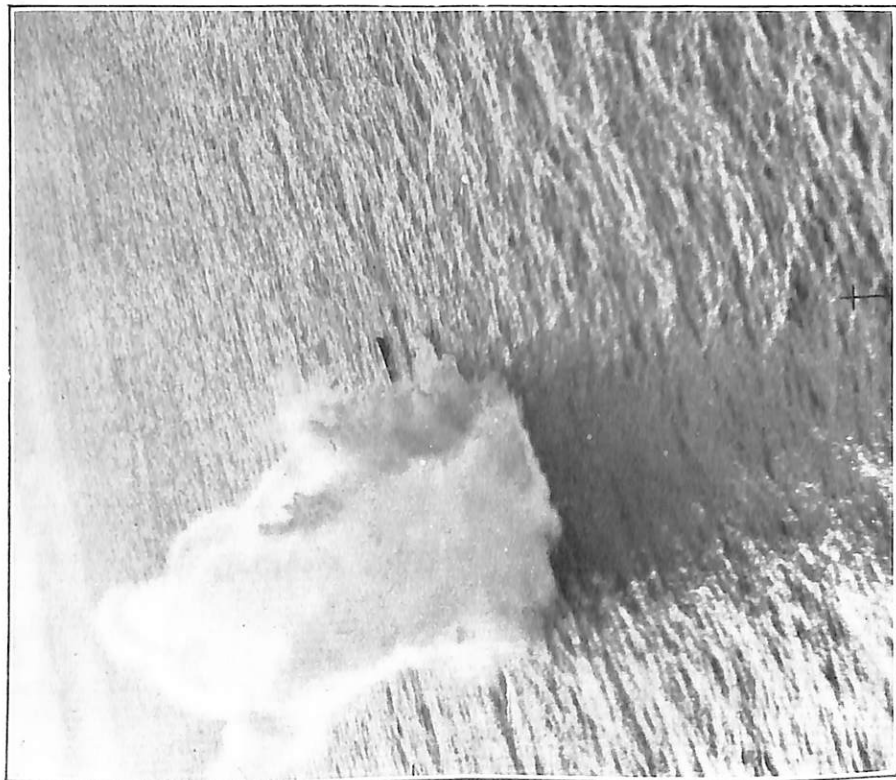
Depth-charges exploding.

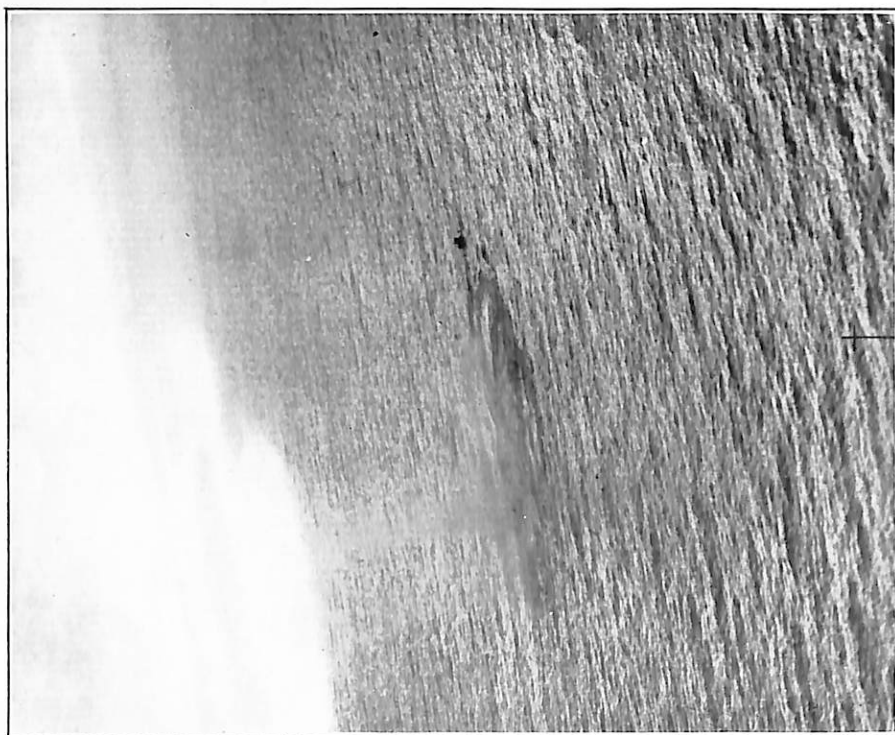
Five seconds after explosion. U-Boat beginning to submerge.

[An example of a bad over-shoot, at least one hundred feet away from this U-Boat.]

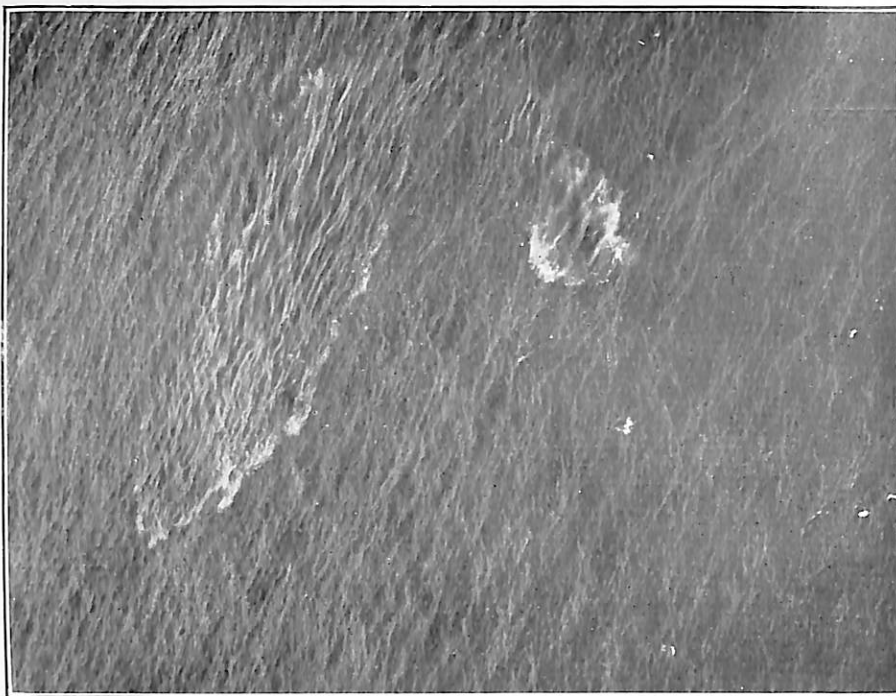
Approximately 35 seconds after attack. U-Boat's swirl in relation to depth-charges.
