# **COASTAL COMMAND REVIEW**

**March 1945**

**Vol. IV, No. 3**

**HEADQUARTERS,  
COASTAL COMMAND  
ROYAL AIR FORCE**

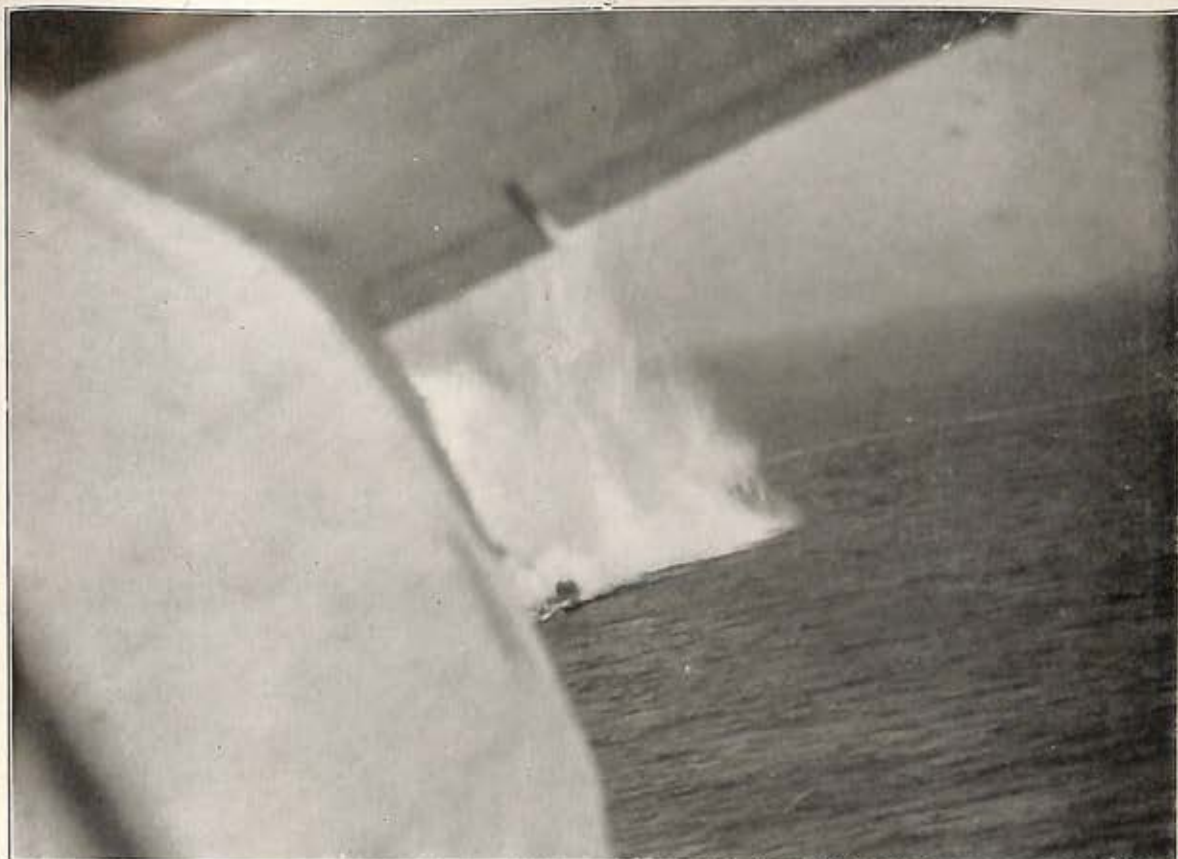
These photographs are the first obtained of a depth charge attack on a U-Boat for a considerable time, and were taken by N/103 (U.S.N.) Squadron. In the upper print the spray from main depth charge attack is seen subsiding while a late explosion is developing on the U-Boat's starboard quarter.

In the lower photograph a big explosion, thought to be that of the batteries, is developing as the U-Boat sinks. (See letterpress, page 10.)
